TO: Council
FROM: Facilities Planning and Construction
DATE: February 17, 2026
RE: Summary – Ice Rink Closure Root Cause Analysis

Brennan Park Recreation Centre - Ice Arena Humidity Review *1009 Centennial Way, Squamish, BC.*

Prepared By:
Summit Building Consultants Inc.
555 Burrard Street,
Vancouver. BC. V7X 1M8

Date: December 1, 2025
Revision: R3 – Public release

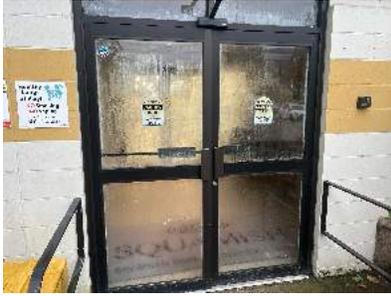
A review of the building automation system (BAS) during the site visit indicated that the natatorium air-handling and dehumidification unit was not operating as intended at that time. BAS readings indicated relative humidity levels in the natatorium of 100%, representing a significant adjacent moisture source. This condition increases the potential for moisture migration into the arena through both permanent and temporary air leakage paths.

Condensation on Natatorium entrance doors due to failed AHU.

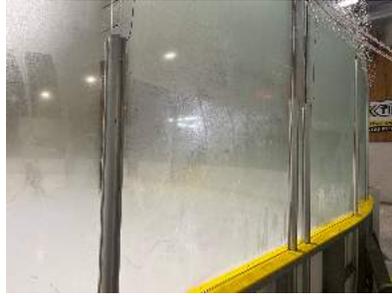
Condensation on the ice arena glass

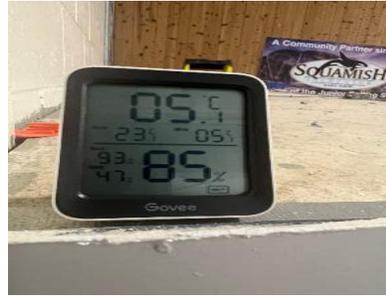
The arena air temperature at the time of the site visit was measured at 5-6°C using handheld instrumentation. Relative humidity readings taken within the arena using a handheld hygrometer were generally in the range of 78–85% RH.

Observed temperature and humidity within the Ice arena space

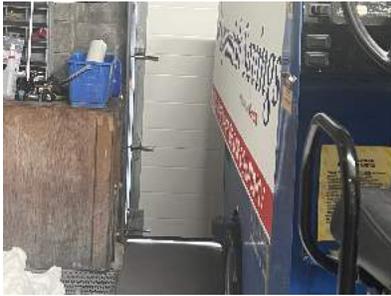
The Zamboni room is connected to the exterior via a large overhead door. Based on information available at the time of the review, the original roller-door assembly was removed following failure and is awaiting replacement. At the time of Summit's site visit, the interim door condition provided limited resistance to air infiltration when opened, resulting in a direct air path between the exterior and the Zamboni room during resurfacing and service activities.

Gaps in the Zamboni room exterior door

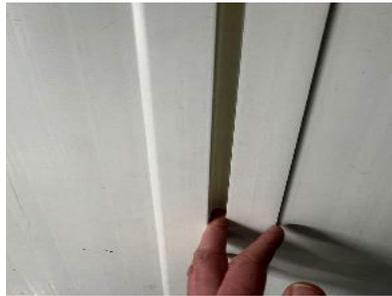
Multiple door openings were observed around the perimeter of the ice arena, estimated to be twelve in total, connecting the arena to exterior areas, the Zamboni room, and adjacent interior spaces. None of these doors include vestibules or airlocks.

Examples of gaps at all exterior doors

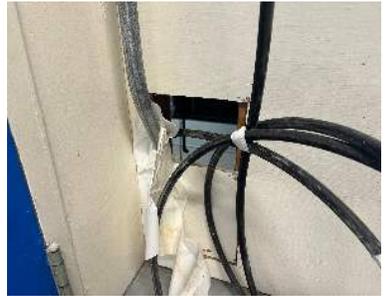
Large gaps and openings were observed in the temporary hoarding installed along the south side of the arena. These included unsealed penetrations and areas of incomplete enclosure that create direct air leakage paths between the arena, adjacent recreation spaces, and construction zones. During the site visit, at least one exterior door serving the construction or service areas was observed in a propped-open position, further confirming uncontrolled air pathways into the arena.

Holes in Natatorium temporary wall

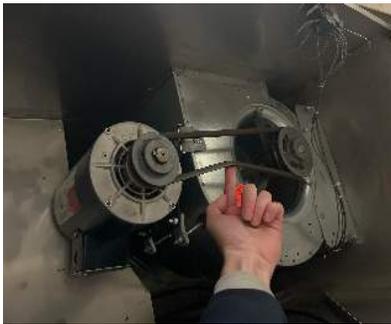
The fan belt assemblies were observed to have visible belt deflection in excess of manufacturers recommendations when checked by hand. Improper belt tension can reduce airflow and overall dehumidifier performance.

Large deflection on Dehumidifier DH-1 fan belt which needs to be adjusted.

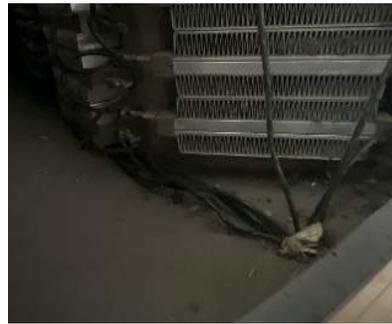
Upon opening the unit access panels, a noticeable accumulation of dirt and debris was observed within the electric duct heater sections of the dehumidifiers. Cleaning of these heater sections is required to ensure proper heat transfer and reliable operation.

Insects and debris covering the dehumidifier electric duct heaters

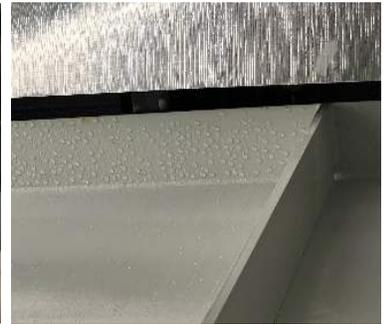
Within the ice arena, active condensation was observed on structural steel elements above the seating and circulation areas. Evidence of historic dripping was noted on steel members and adjacent surfaces, including staining consistent with repeated condensation events.

Considerable condensation on the steel structure

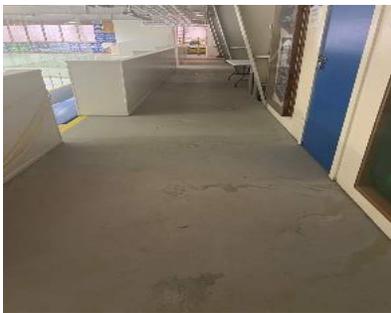
Various water drips on walkways and seating areas within the arena

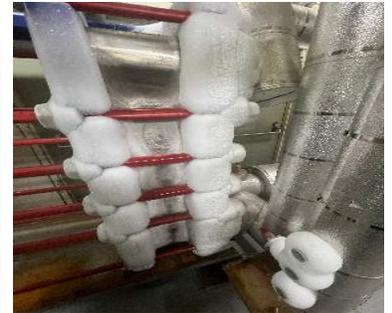
Considerable ice build-up on Brine system components

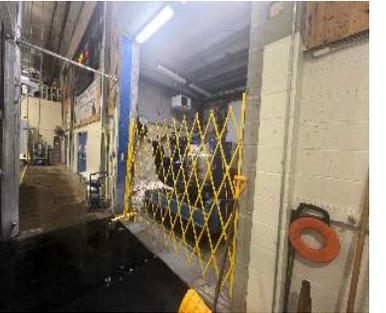
Missing Zamboni room door
